# STRUCTURAL REPAIR: EPOXY INJECTION

**Project:** Column Repair, Spur 156 @ I-20

**System:** Sikadur 35 Hi-Mod LV  
SikaWrap Hex 117C  
Sikagard 670W

**Completed:** 2005

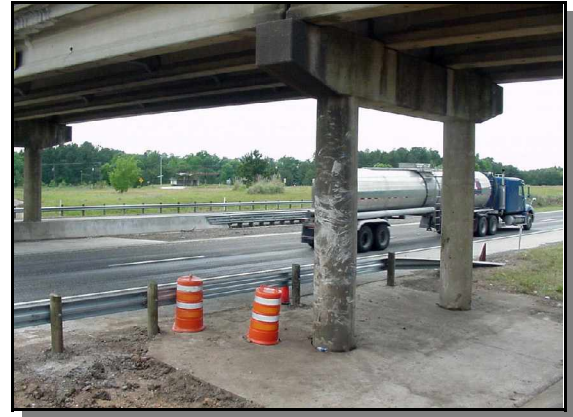
**Before**

An 18-wheeler impacted and severely damaged a bridge support column on westbound I-20 near the border. After review by a structural engineer, it was determined that some of the vertical reinforcing steel may have been deformed by the impact. Mobile Enterprises, Inc. was contacted to perform the emergency repairs.
