STRUCTURAL REPAIR: COMPOSITE STRENGTHENING

Project: Corporate Headquarters
Garage Repairs, Phase 3

System: Carbon Fiber Composite
Strengthening System

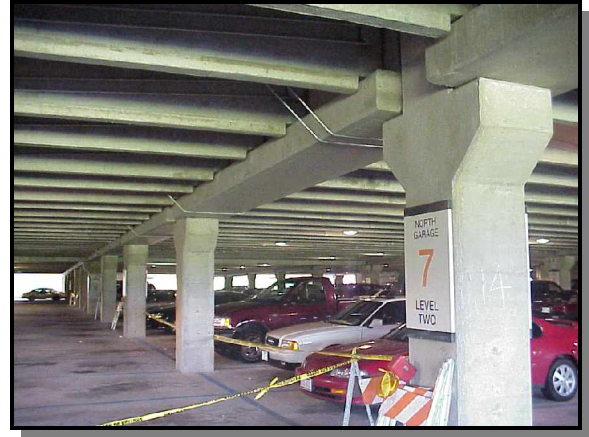
At a corporate headquarters located in North Texas, problems were discovered in many of the precast beams that support the floor structure of the North and South Parking Garages. Phase 3 of the repair work included the application of a two-layer, carbon-fiber wrap system to the bottom surface of the precast, pre-stressed inverted "T" beams.

An acrylic topcoat was applied to the black carbon-fiber fabric making the repaired beams barely noticeable.
