# Parking Garage Repair & Protection

**Project:** Corporate Headquarters  
Garage Repairs, Phase 3

**System:** Carbon Fiber Composite  
Strengthening System

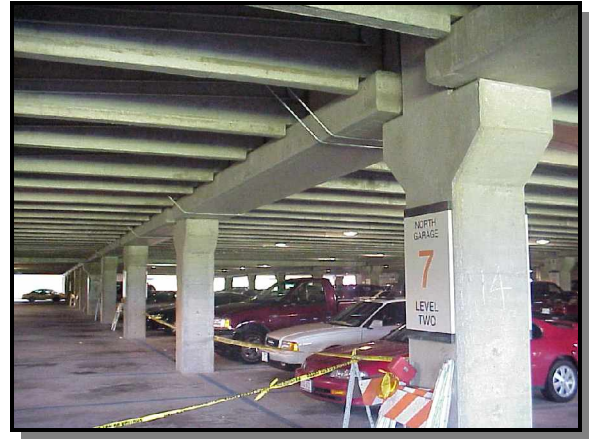
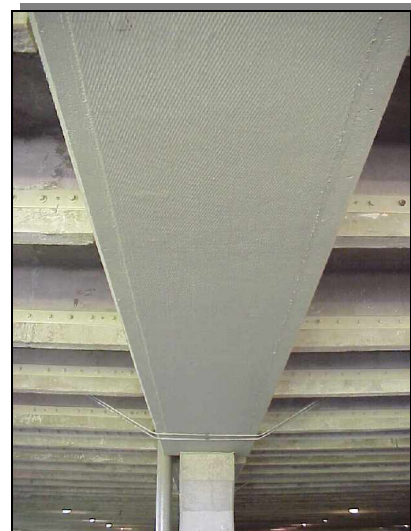
At a corporate headquarters located in North Texas, problems were discovered in many of the precast beams that support the floor structure of the North and South Parking Garages. Phase 3 of the repair work included the application of a two-layer, carbon-fiber wrap system to the bottom surface of the precast, pre-stressed inverted "T" beams.

An acrylic topcoat was applied to the black carbon-fiber fabric making the repaired beams barely noticeable.
