WATERPROOFING

Project: Pedestrian Bridge

Owner: Major Periodical Facility

Completed: 2002

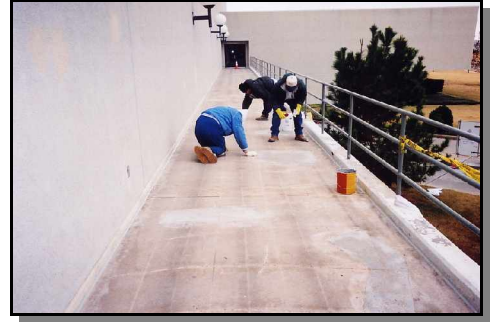
This cantilevered pedestrian bridge was experiencing severe spalling. Cracks, rebar corrosion, spalls, etc.

Repairs:

- Chip and key in delaminations
- Blast and coat rebar
- Rebar replacement
- Spall repair using Sika 224
- Shotblast top deck
- Epoxy crack repair
- Waterproof Urethane Deckcoating

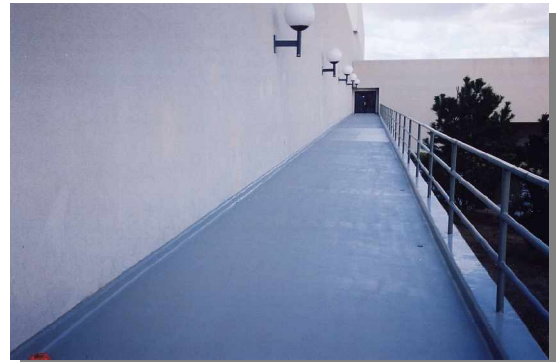
After concrete repair and deckcoating, steel beams were installed by John A. Arnold, general contractors.
