# STRUCTURAL REPAIR: CONCRETE

**Project:** Energy Plant  
**Location:** Central Texas  
**Systems:** MBT Emaco S-77 CI  
MBT Emaco S-88 CI  
MBT M-Brace Composite  
**Quantities:** 106 CF Repair Material  
450 SF M-Brace

**Completed:** 2003

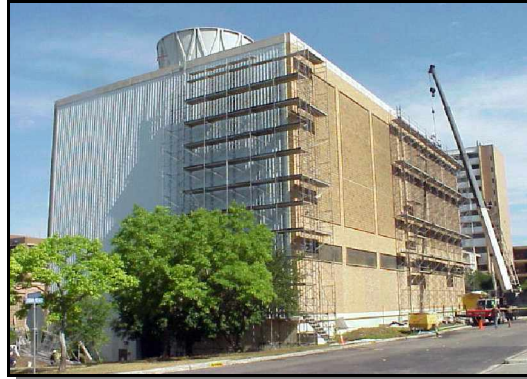
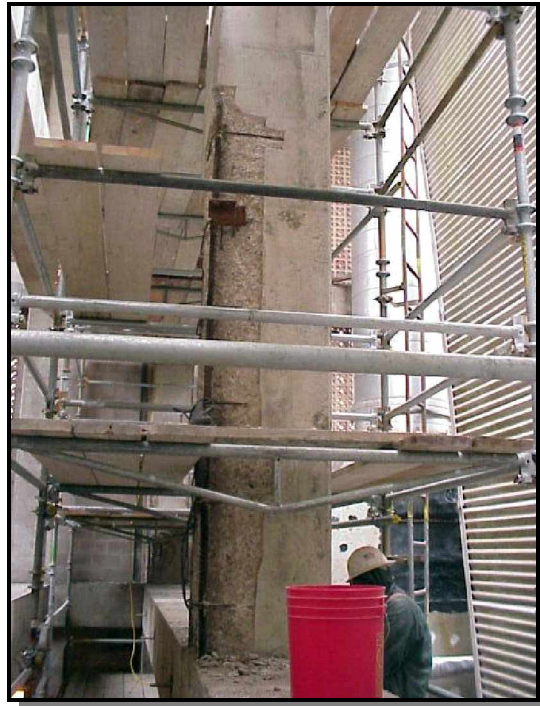
The constantly humid atmosphere inside the enclosure allowed moisture to migrate through cracks in the concrete columns and beams, rusting the reinforcing steel, and spalling the concrete cover.

Scaffolding had to be erected around a myriad of piping and equipment to access the areas requiring repair in the 48-foot tall enclosure. Loose and unsound material was removed, edges were sawcut, exposed reinforcing steel was cleaned and coated, and over 100 cubic feet of repair material was placed, effectively halting further corrosion of the reinforcing steel.

Repairs were completed in 2003, without disruption to the operations.
