STRUCTURAL REPAIR: CONCRETE

Project: State Highway 183 @
MacArthur Blvd. Overpass
Irving, TX

Owner: Texas Department of Transportation
Dallas District

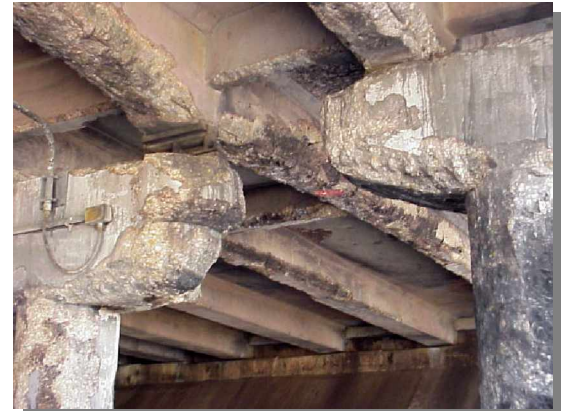
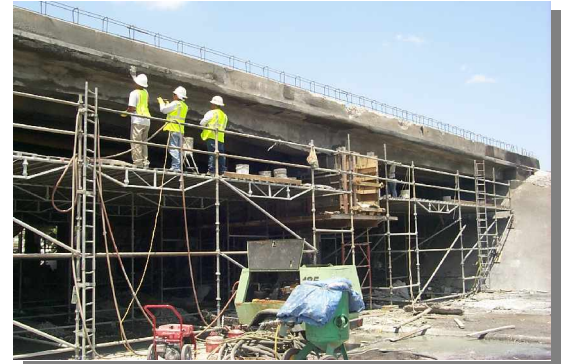
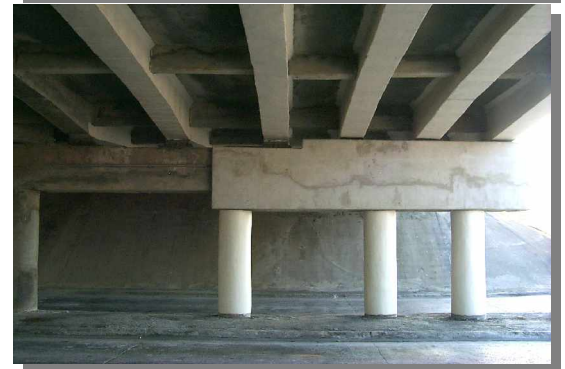
A fatal accident involving a gasoline tanker truck resulted in extensive damage to portions of the eastbound SH 183 bridge structure over MacArthur Boulevard on May 29, 2005. After examination by TXDOT engineers, it was determined that the bridge did not have to be demolished, as first feared. Repair procedures were outlined utilizing spray-applied shotcrete, and form-and pump techniques.

Four days after bids were received on the project, Mobile Enterprises was able to mobilize a sizable crew to begin the extensive repair process. Working on a fixed and very tight emergency repair schedule, Mobile crews worked nights, weekends and on the Fourth of July to remove and replace over 900 cubic feet of damaged concrete on the bridge beams, columns, bent caps, diaphragms and slab soffits. Repairs were completed in only 19 days, and traffic was restored three days ahead of schedule.
