# PARKING GARAGE REPAIR & PROTECTION

**Project:** MALL PARKING GARAGE

**System:** Waterproof Deck Coating System

**Completed:** 1990

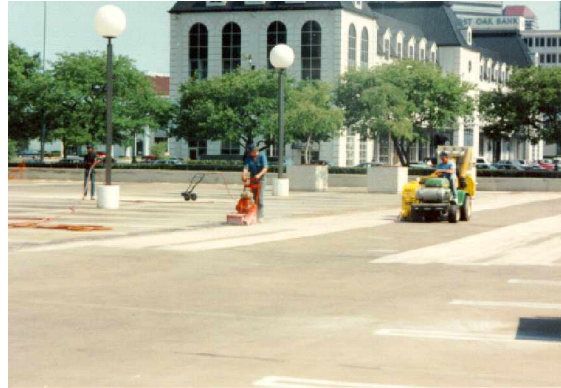
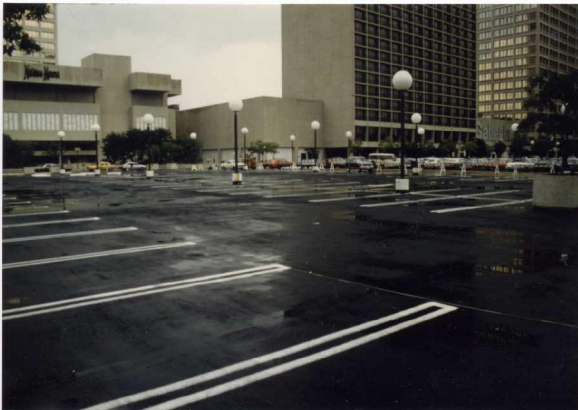
The garage had a number of problems including, but not limited to, cracking and spalling of the concrete topping and failed expansion joints. Water was penetrating through these areas and corroding the structural steel.

Mobile Enterprises has successfully stopped water penetration. Spalled concrete areas were removed and patched. Cracks were chased and sealed, then detailed with fiberglass mesh and neoprene rubber. Cracks discovered in structural members were pressure injected with epoxy. Failed expansion joints were replaced, and finally the surface was shotblasted and Kelmar waterproof deck coating was installed.
