PARKING GARAGE REPAIR & PROTECTION

Project: Administration Garage #1
Trauma Garage #2

Owner: Medical Facility
Galveston, Texas

System: SikaFloor 450 / 455
Sika Elastocolor

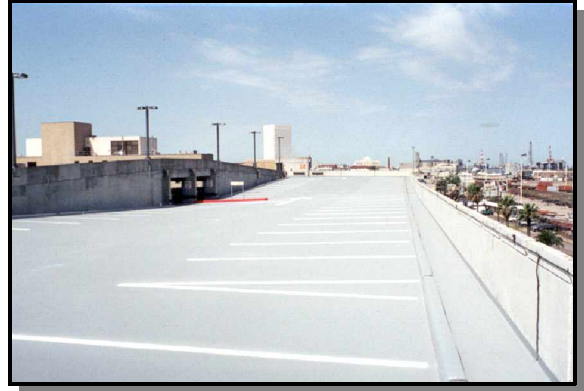
The existing traffic deck membrane on the top, open decks of Garage #1 and Garage #2 had deteriorated badly, allowing water to penetrate cracks in the concrete deck and drip on parked cars below. In addition, moisture in the cracks attacks the reinforcing steel, causing additional damage.

Mobile Enterprises crews routed and sealed cracks and joints, shotblasted and waterblasted the surfaces and installed the SikaFloor 450 / 455 Traffic System. In addition, the parapet walls on all levels were prepared and coated with ElastoColor to match the original colors.
