# WATERPROOFING: INJECTION

**Project:** Seal Leaks in Underground Vaults

**System:** DeNeef CombiGrout

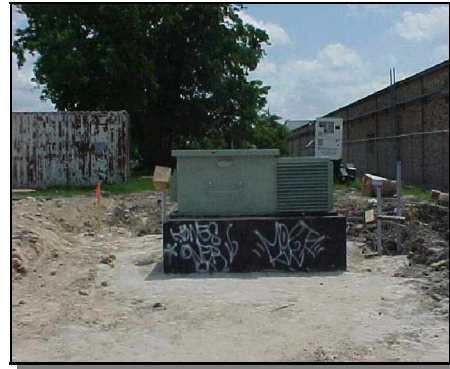
A manufacturer of pre-fabricated, controlled-environment, concrete vaults that are used for many underground placements had two vaults located in high water table locations that were leaking through the walls preventing installation of very sensitive, expensive communications equipment. The floors of the vaults are approximately 22" to 25" below grade and are waterproofed on the exterior before backfilling. In these cases, the exterior waterproofing failed and the vaults were filling up with groundwater intruding through hairline cracks and /or honeycombs in the walls.

Mobile Enterprises, Inc. was called to get the leaks stopped so equipment could be installed and put into operation. Injection holes were drilled completely through the walls and a hydrophilic urethane gel was injected between the exterior wall and backfill to create a waterproofing membrane to stop the leaks.

The leaks were stopped and the equipment installation proceeded as scheduled.
